RUSH RESERVOIR  
MONROE COUNTY  
NEW YORK

INVENTORY No. NY 1341

PHASE I INSPECTION REPORT  
NATIONAL DAM SAFETY PROGRAM

MAY 1981

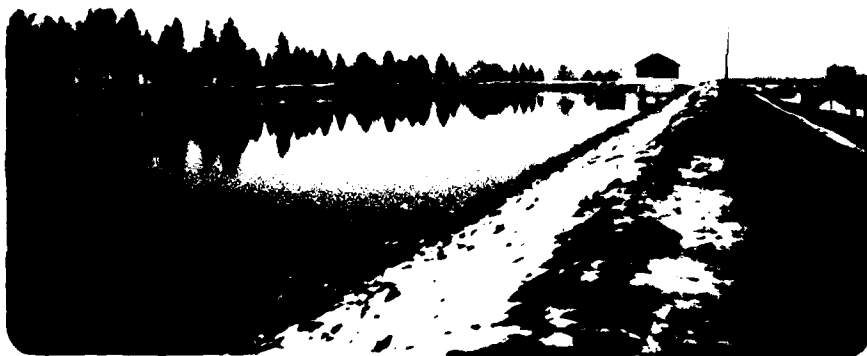
3. Top of southeast embankment.
